# Service Bulletin

Bulletin No.: PI1513F

**Subject:** Coolant Smell and/or Slight Leak at Radiator

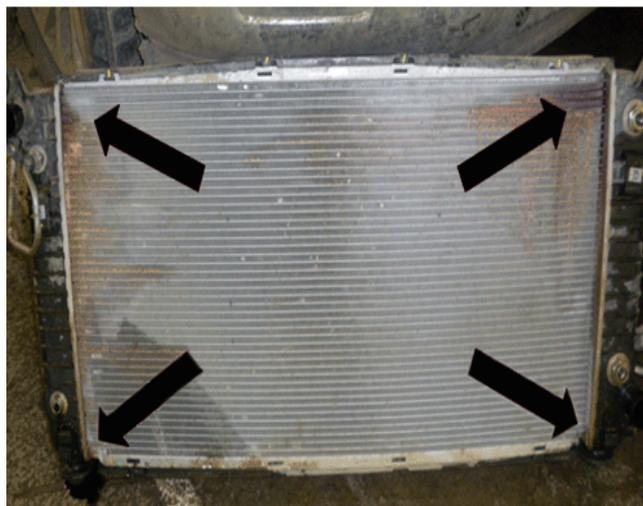
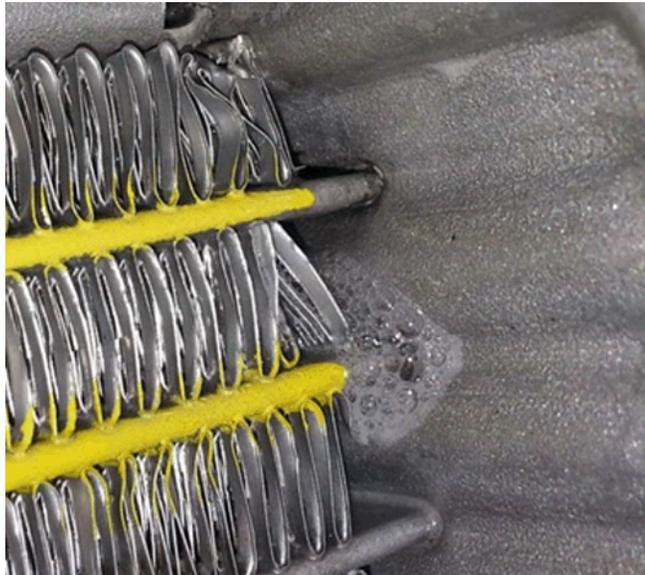
4082322

Technicians should start by inspecting the radiator for signs of leaks. Normally, signs of leaks can be found where the tubes attach to the headers.

This condition may be the result of excessive thermocycles within the cooling system caused by excessive cycling of the thermostat. These excessive thermocycles within the coolant system may cause the tubes to fatigue, crack and leak at the radiator headers. To correct this condition, a new thermostat has been designed that eliminates the thermostats excessive cycling.

If this condition is found, in addition to replacing the radiator, the engine coolant thermostat housing (w/thermostat) must also be replaced. Refer to *Engine Coolant Thermostat Housing Replacement* in SI, which is located in the Engine Heating and Cooling section.
